# Runoff Reduction Field Monitoring in Cherry Creek Basin

Prepared for:  
Mile High Flood District  
Southeast Metro Stormwater Authority  
Cherry Creek Basin Water Quality Authority

Prepared By:  
Chris Olson, PhD, PE  
Stacy Wilson  
2490 West 26<sup>th</sup> Avenue, Suite 100A  
Denver, CO 80211  
(303) 480-1700

June 2024

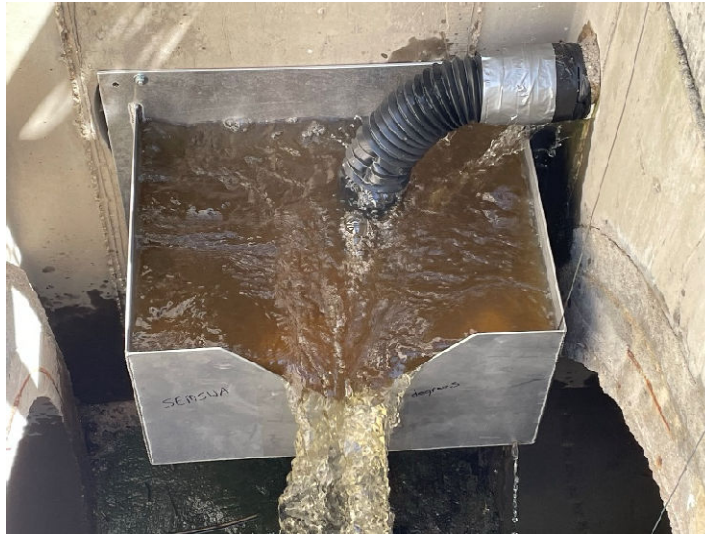
1. Some leaking from the bottom of the underdrain was noted. Field observations estimate the unmeasured discharge to be 2 gpm (Figure 2).

**Figure 2. Leaking from the bottom of the underdrain during SRT**

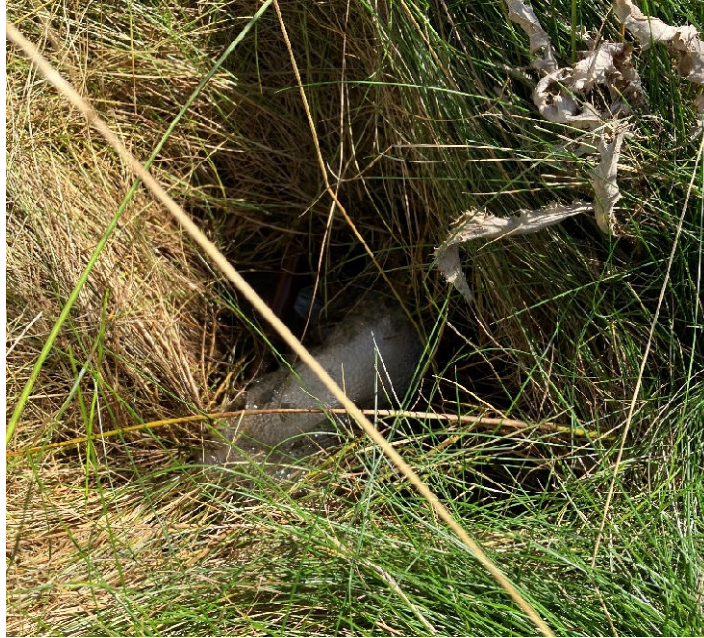
2. Some leakage from the irrigation system was noted during the SRTs adding unmeasured inflow to the swale (Figure 3), however, the rate and volume was relatively minor compared to the SRT inflows.

**Figure 3. Leaking from irrigation system**

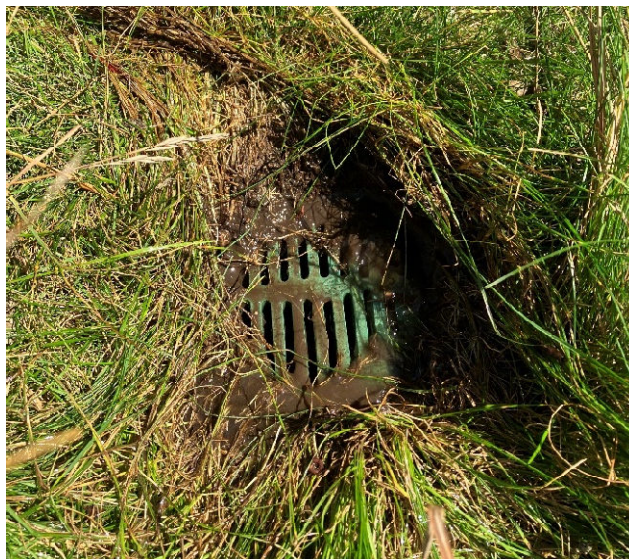
3. Prior to performing the SRTs, SEMSWA staff installed solid caps on three underdrain cleanouts that previously had slotted caps. A fourth cleanout was discovered during the September 6 SRT at approximately 74 feet down the length of the swale that had a slotted cap at ground level (Figure 4). Surface flow was observed draining into the slotted opening at an approximate rate of 5 gpm, based on visual observations by field staff. The cleanout cap was plugged with duct tape for subsequent SRTs.

**Figure 4. Fourth cleanout discovered during September 6, 2023 SRT**

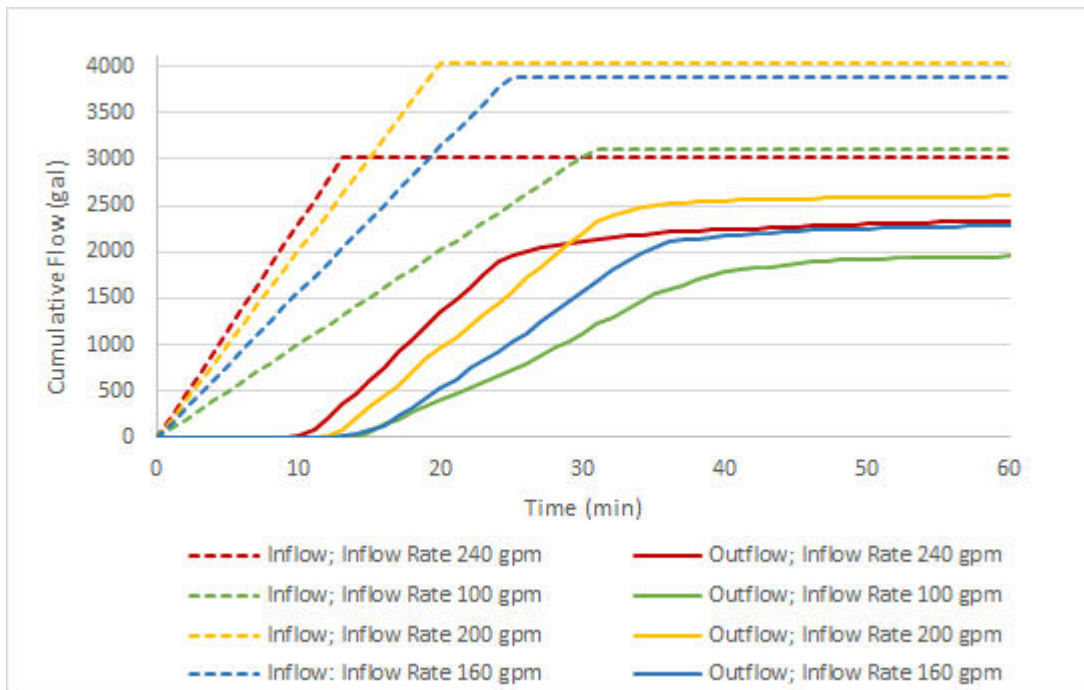
The total inflow volume for the four SRTs ranged from 3,000 – 4,100 gallons, and the total outflow ranged from 2,000 – 2,600 gallons (Figure 5). The runoff volume reduction observed for the four SRTs ranged from approximately 20 – 40% (Figure 5 and Figure 6). The lowest volume reduction of 21% occurred during the first SRT, with the smallest inflow volume (3,000 gallons) applied at the highest inflow rate (240 gpm). The greatest volume reduction (40%) was observed during the fourth SRT, with an inflow volume of 3,900 gallons at a rate of 160 gpm.

**Figure 5. Cumulative inflow and outflow volumes for SRTs at the SEMSWA site**

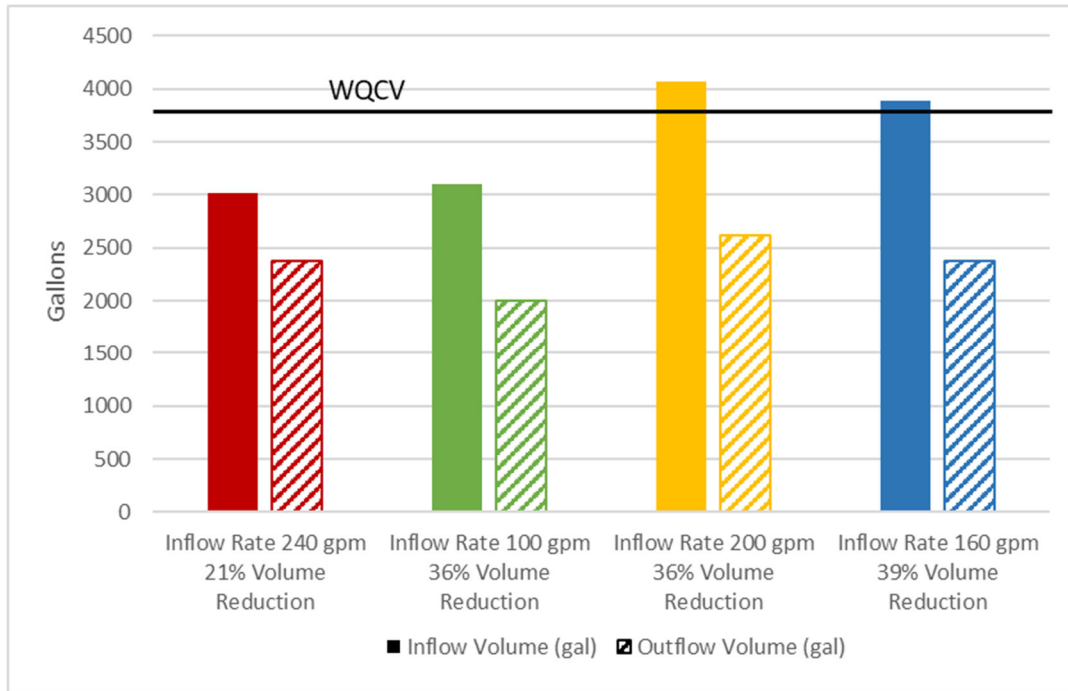
**Figure 6. Volume reduction observed for SRTs at the SEMSWA site**

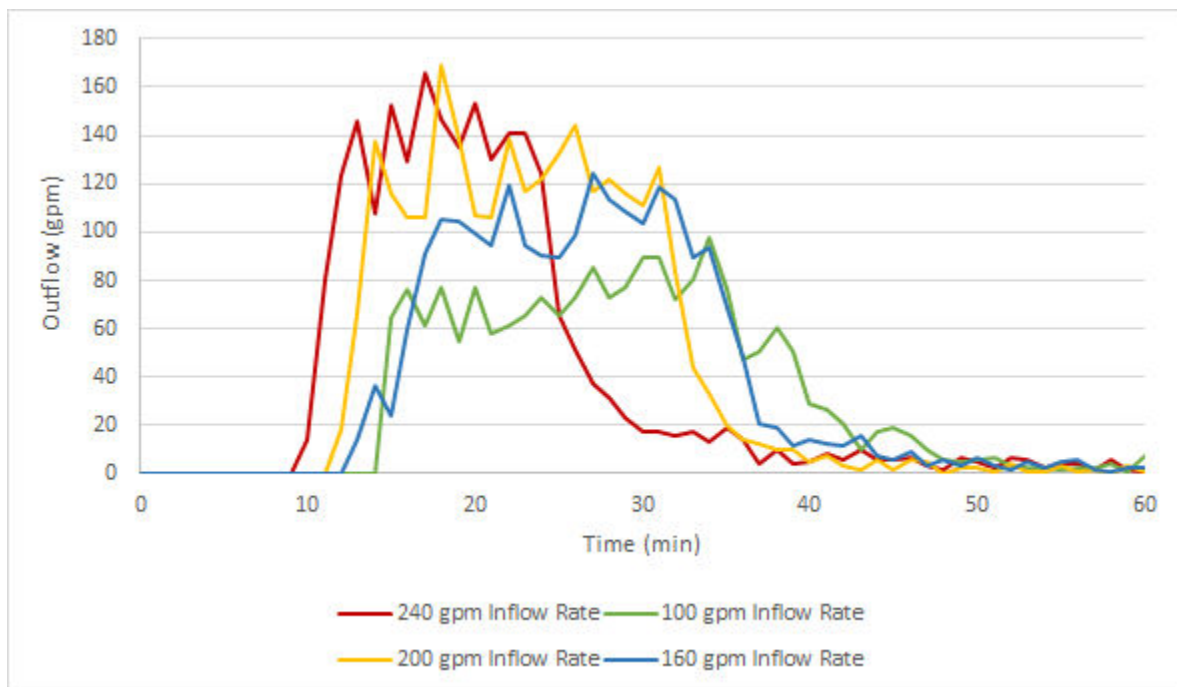
The maximum inflow rate varied between 100 – 240 gpm for each of the SRTs, and the peak outflow rate varied between 98 – 170 gpm (Figure 7). The reduction in peak flow rate ranged from 3 – 30% (Figure 7 and Figure 8).

**Figure 7. Instantaneous weir outflow during SRTs at the SEMSWA site**

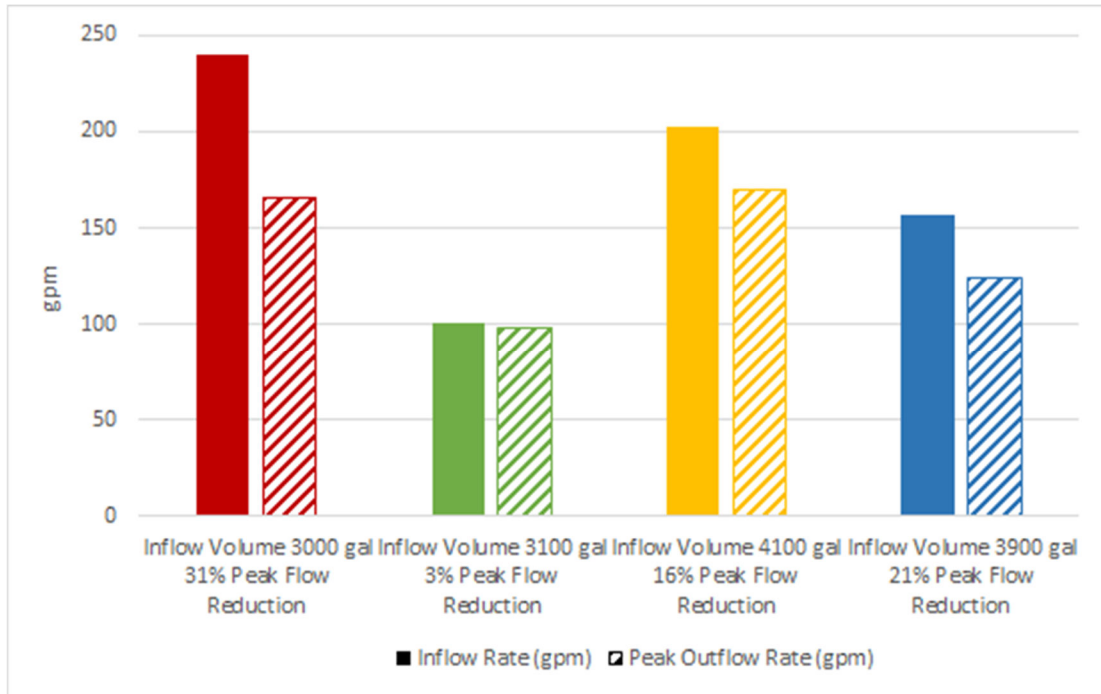
**Figure 8. Peak flow reduction observed at SEMSWA SRTs**

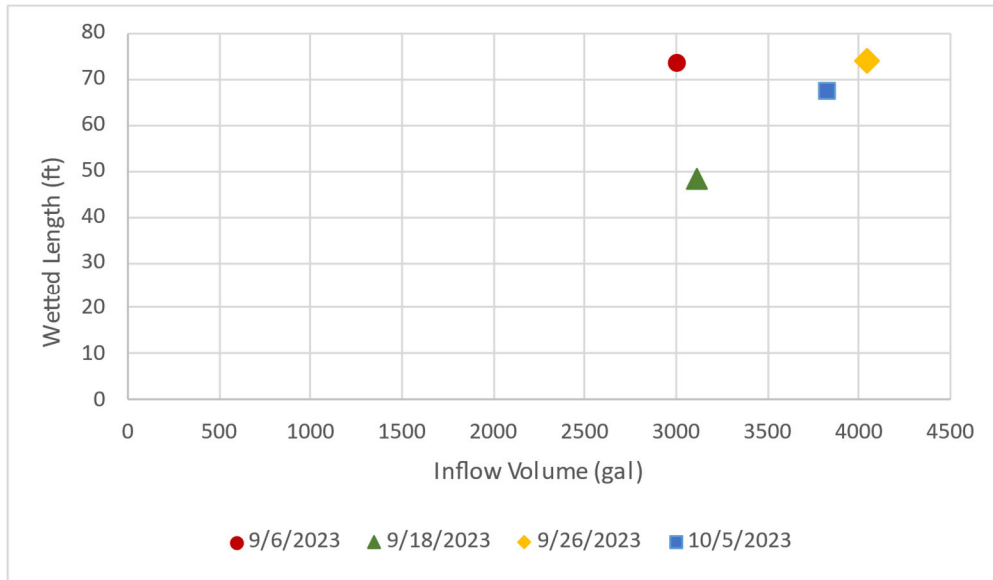
**Figure 9. Wetted length and total inflow volume during SRTs at the SEMSWA site**

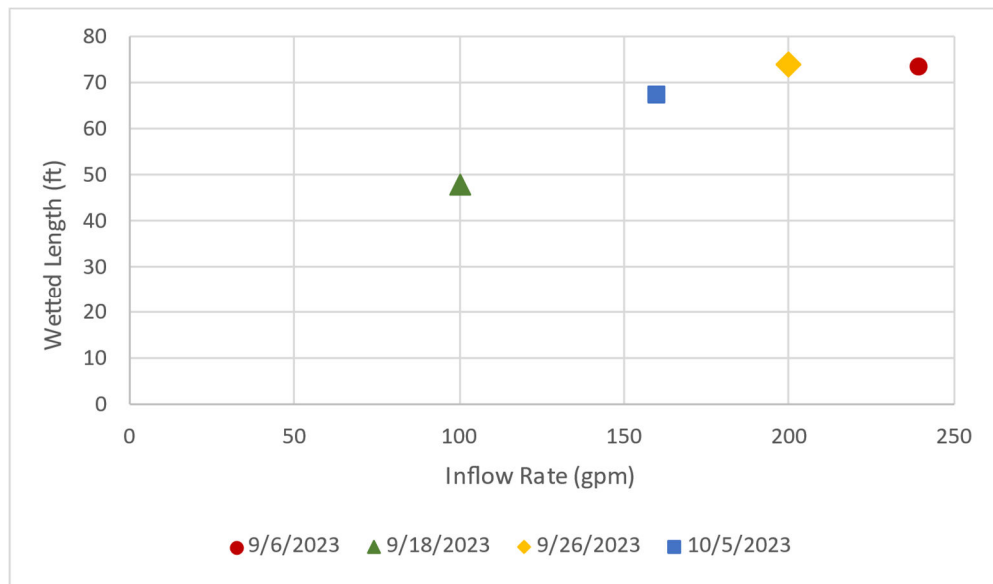
**Figure 10. Wetted length and inflow rate during SRTs at SEMSWA site**

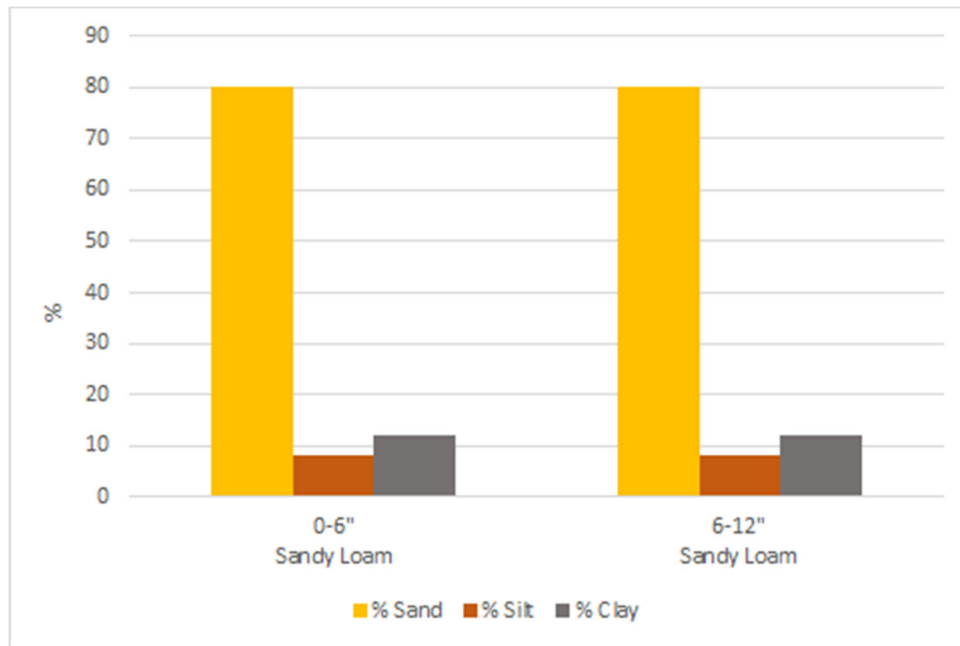
Two 6-inch depth soil cores (0 – 6” depth and 6 – 12” depth) were collected on November 1, 2023, and sent to the Colorado State University SPUR Soil, Water and Plant Testing Laboratory for full chemical and physical analysis. Soil texture analysis of both samples indicated the media at the SEMSWA site consists of sandy loam soil (Figure 11). The soil gradations are consistent with what was specified in the design drawings (Muller, 2014) and MHFD criteria for bioretention media. The full soils report, including chemical analysis, is included in Appendix 2.

Figure 11. Soil texture analysis of SEMSWA site

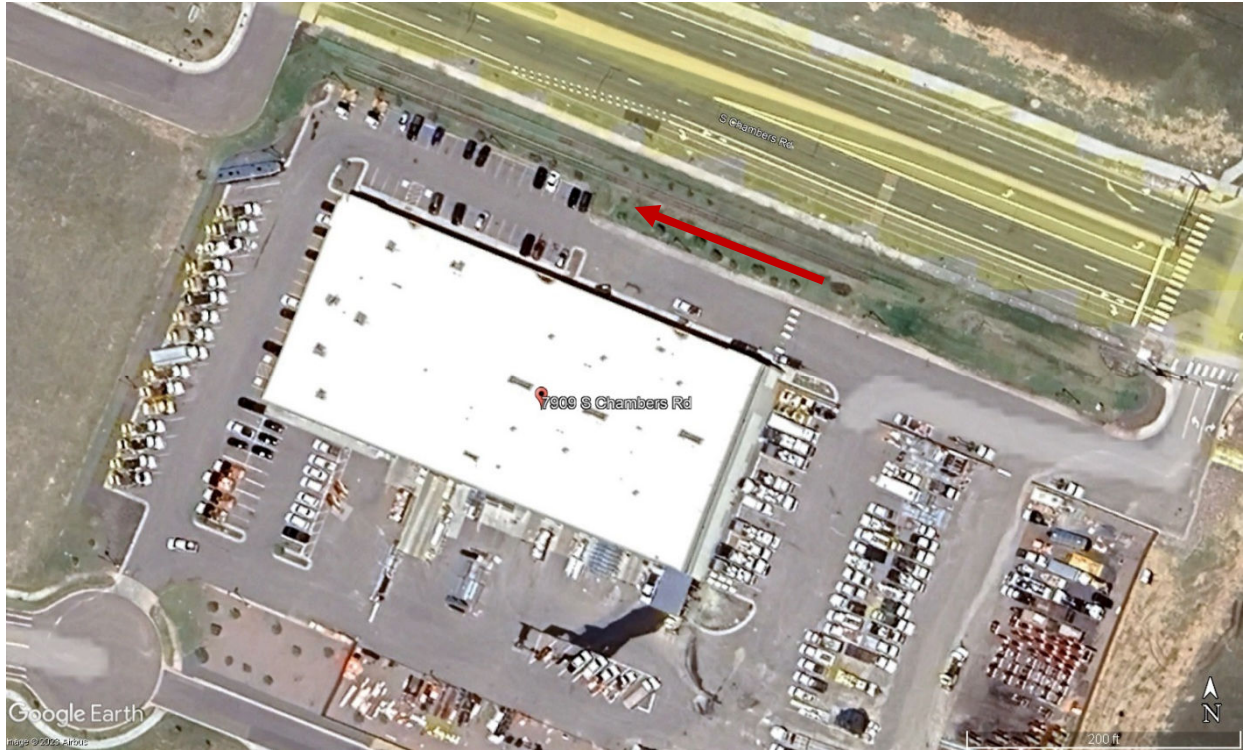
approximately 167 feet long with a bottom width of 2 feet, 4:1 side slopes, and 0.003 longitudinal slope (Table 7). The estimated UIA:RPA for the grass swale is approximately 122:1.

**Figure 12. RoadSafe site with combination grass buffer and grass swale with red flow direction arrow**  
(Google Earth image)

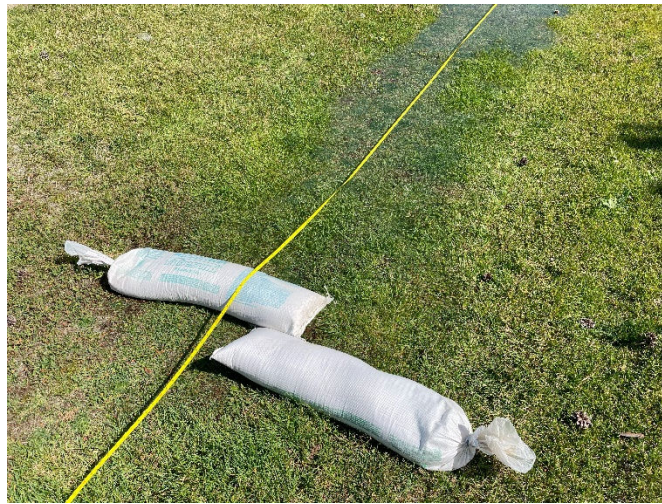
This SRT was conducted with the objective of determining how sandbags placed end to end (check dams) within the swale could increase runoff reduction (Figure 13). For this SRT, sandbags were placed across the swale at locations approximately 25 feet, 50 feet, and 75 feet downstream of the inflow location (Figure 14). The inflow rate was set at 55 gpm and inflow was shut off once the surface flow reached 75 feet, for a total inflow volume of 900 gallons. Inflow continued to extend to approximately 105 feet and did not overflow into the outlet box. A small amount of discharge was visible through the underdrain, however, it was too small to accurately measure. The results of this SRT demonstrated that the swale could capture and infiltrate at least double the inflow from the second test (400 gallons infiltrated) by implementing relatively simple check dam retrofits.

**Figure 13. Two sandbags placed end to end functioned as check dams during the third and fourth SRTs at RoadSafe**

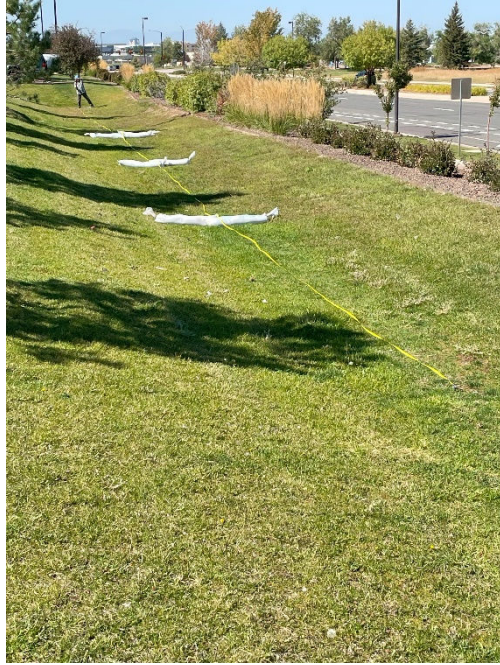
**Figure 14. Three sandbag check dams placed at 25, 50, and 75 feet down the length of the grass swale during the third SRT at RoadSafe**

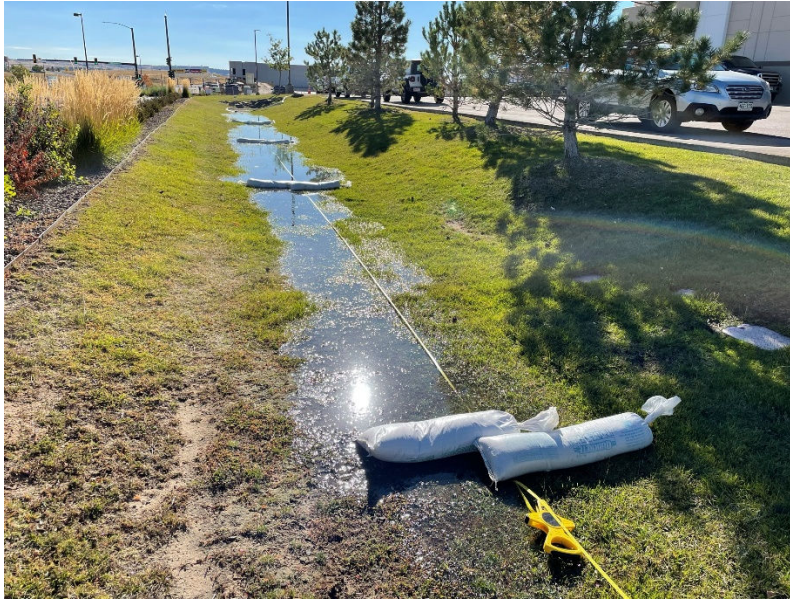
This SRT was conducted with the objective of further evaluating how check dams placed within the swale could increase runoff reduction. Based on results from the previous SRT, additional sandbags were placed approximately 100 feet downstream of the inflow location. Therefore, this SRT was conducted with sandbag check dams at 25 feet, 50 feet, 75 feet, and 100 feet downstream of the inflow location (Figure 15).

**Figure 15. Four sandbag check dams installed at 25, 50, 75, and 100 feet down the length of the grass swale during the fourth SRT at RoadSafe**

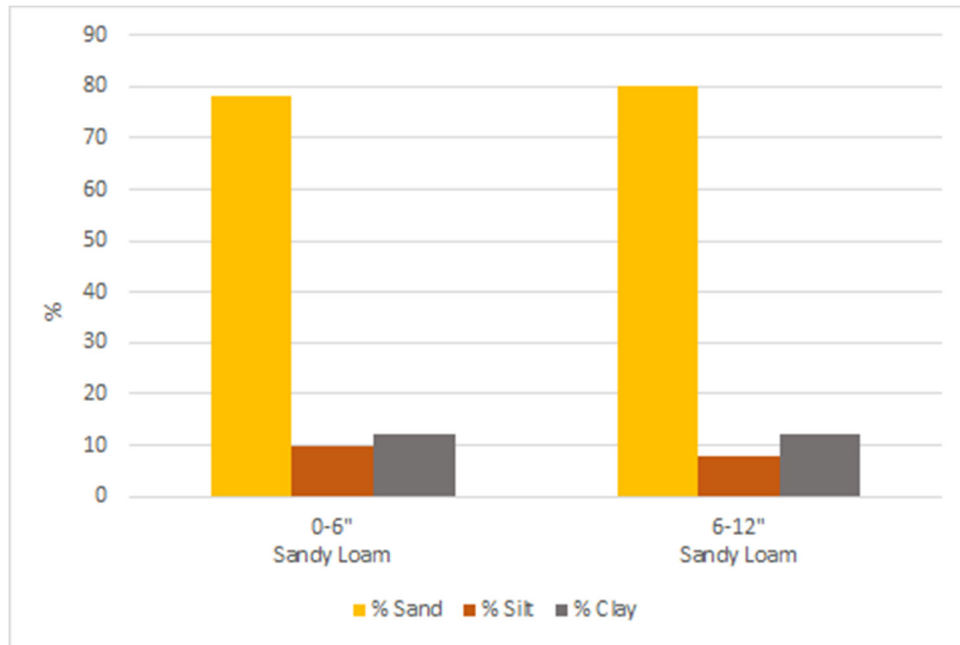
Figure 17. Soil texture analysis of RoadSafe site

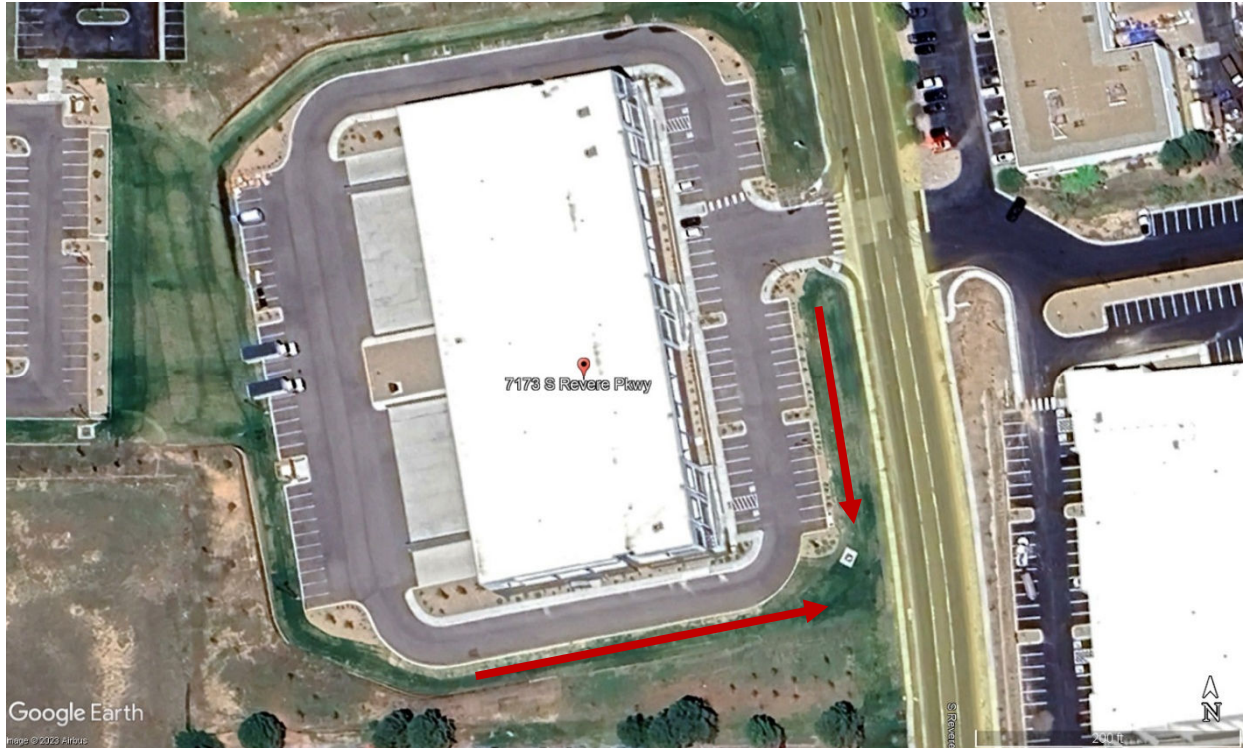
According to the drainage report (WBC Engineering & CM, 2019), 25,600 sf of UIA drains to the 2,600 sf south RPA, and 7,600 sf of UIA drains to the 850 sf southeast RPA. The combined UIA:RPA ratio for both swales is 10:1, and the UIA:RPA for the southeast swale only is 9:1. Design characteristics of both grass swales are included in Table 10. As-builts are dated 2021.

Figure 18. Central Centennial industrial building with two swales draining to single outlet structure (Google Earth image)

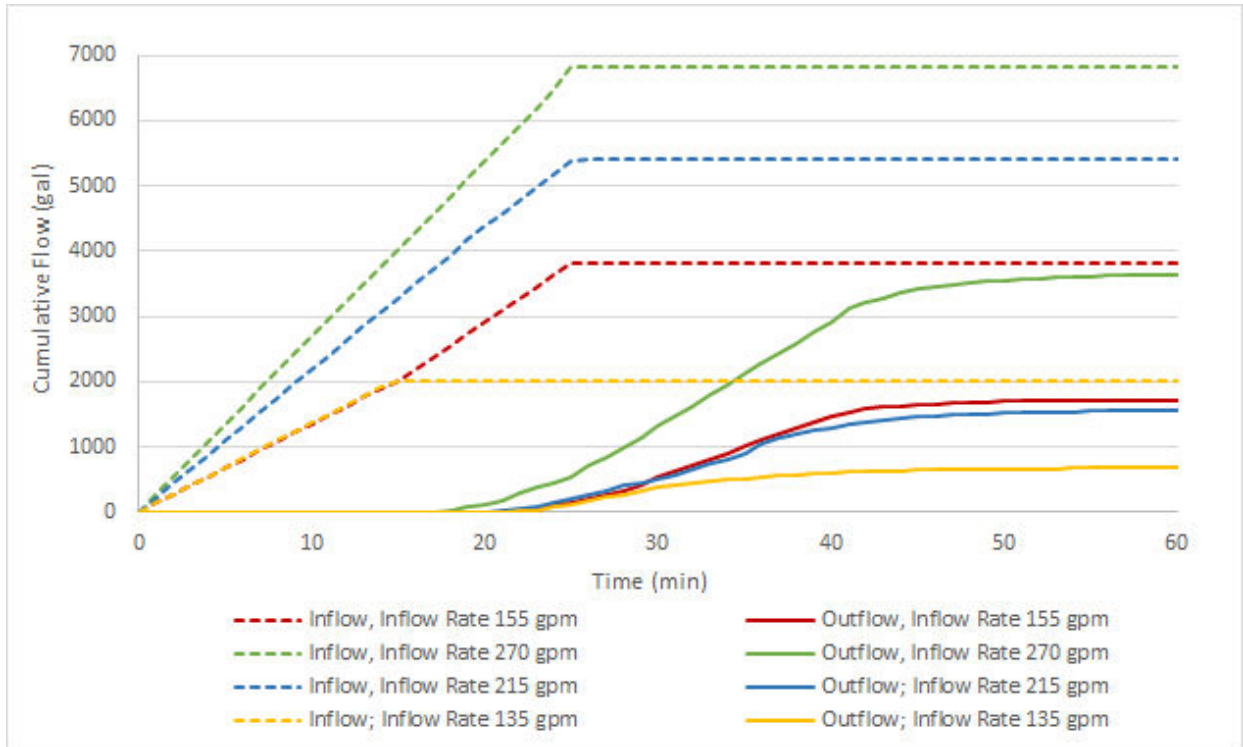
**Figure 19. Cumulative inflow and outflow during SRTs at Central Centennial site**

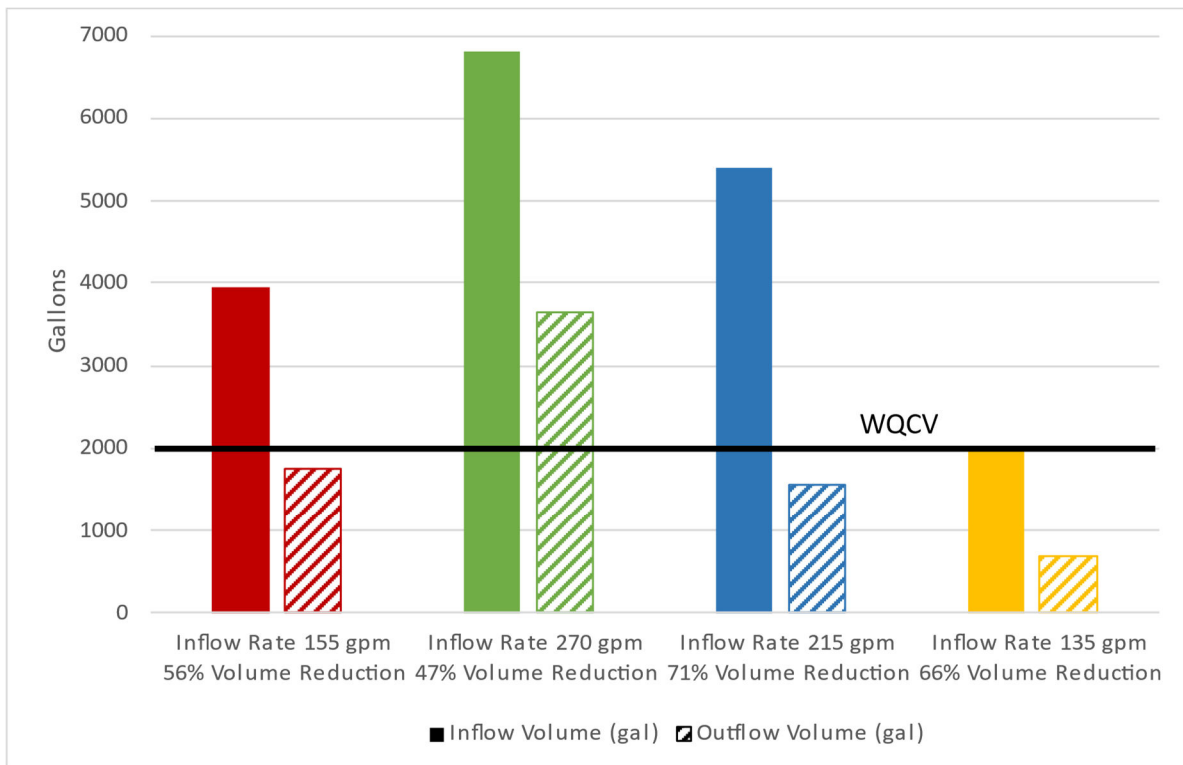
**Figure 20. Volume reduction observed at Central Centennial SRTs**

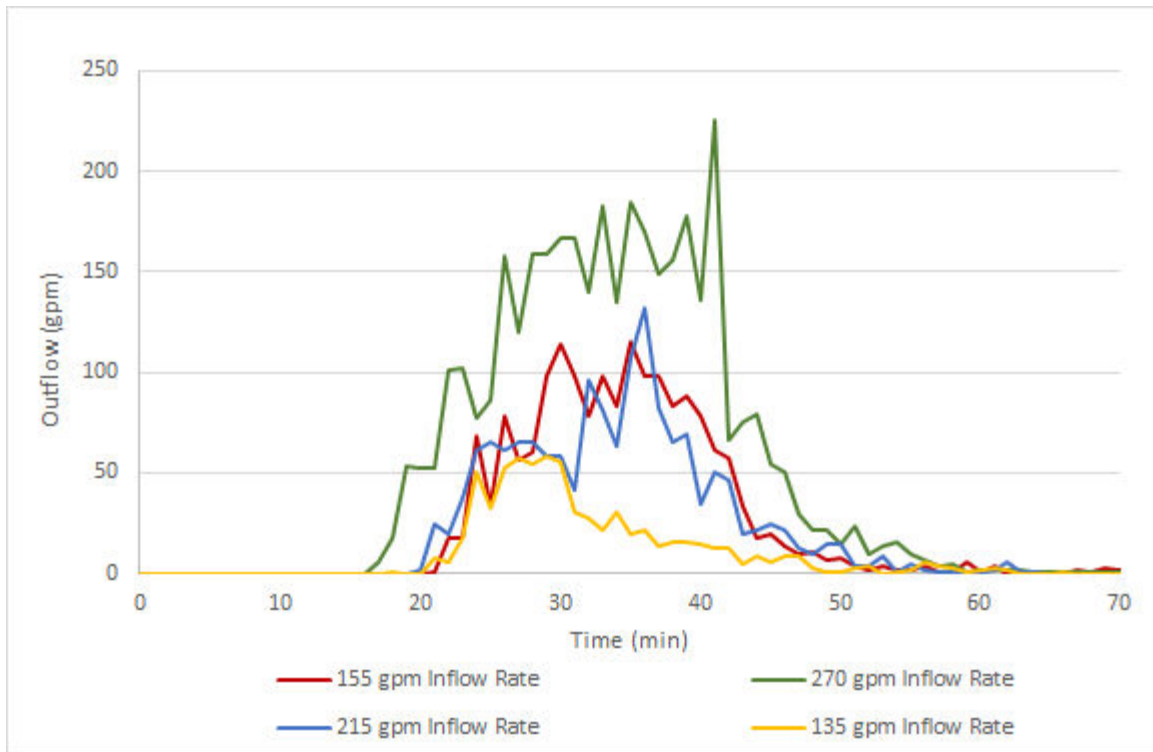
The maximum inflow rate varied between 135 – 270 gpm for each of the SRTs, and the peak outflow rate varied between 60 – 225 gpm (Figure 21). The reduction in peak flow rate ranged from 15 – 55% (Table 12 and Figure 22).

**Figure 21. Instantaneous weir flow during SRTs at Central Centennial Site**

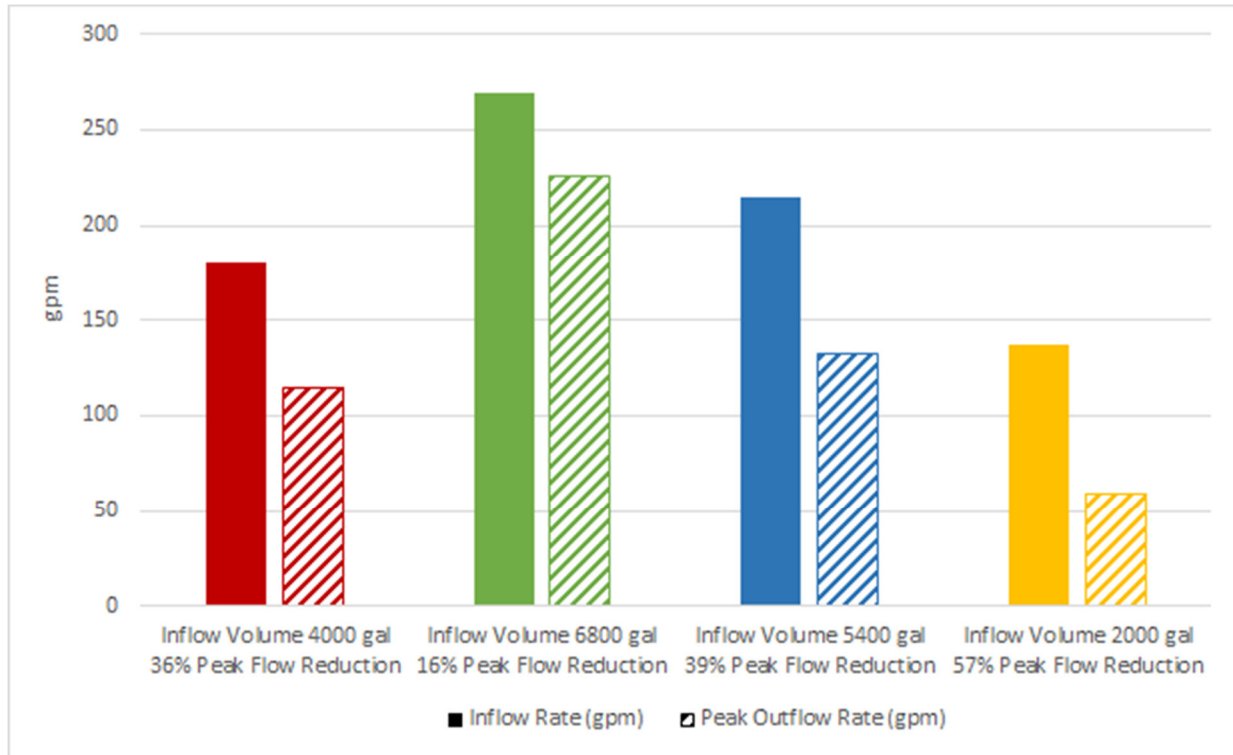
**Figure 22. Peak flow reduction observed at Central Centennial SRTs**

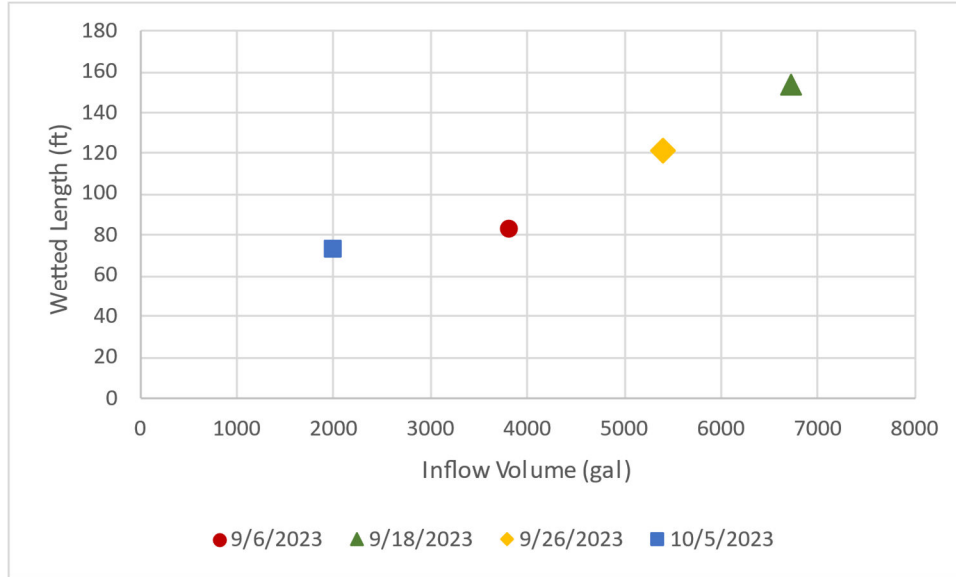
**Figure 23. Wetted length and inflow volume during SRTs at Central Centennial site**

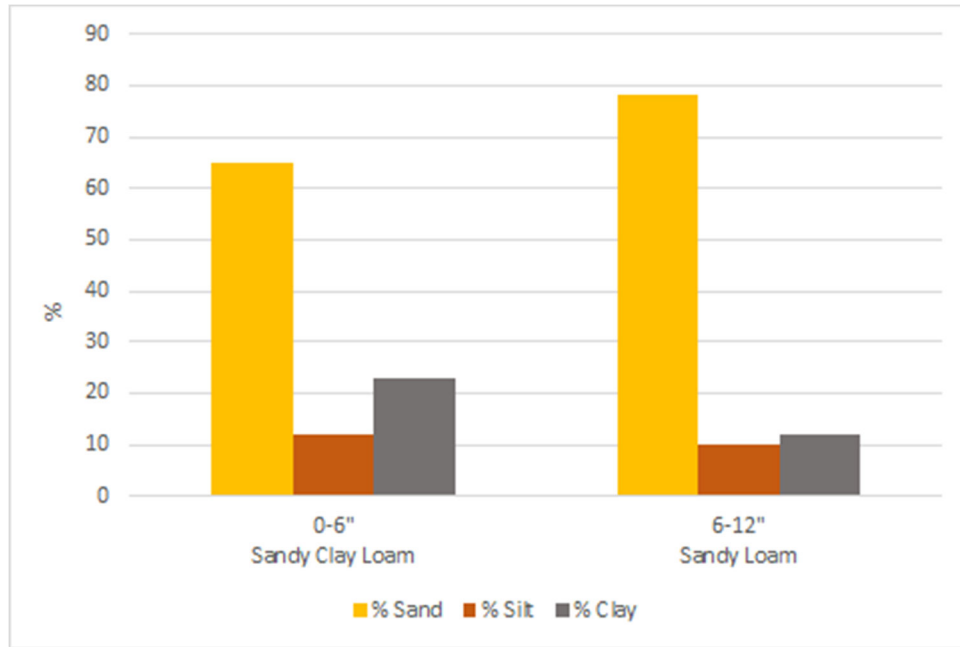
The soil gradations are consistent with the construction drawings, which reference the MHFD bioretention media specifications.

**Figure 25. Soil texture analysis of Central Centennial site**

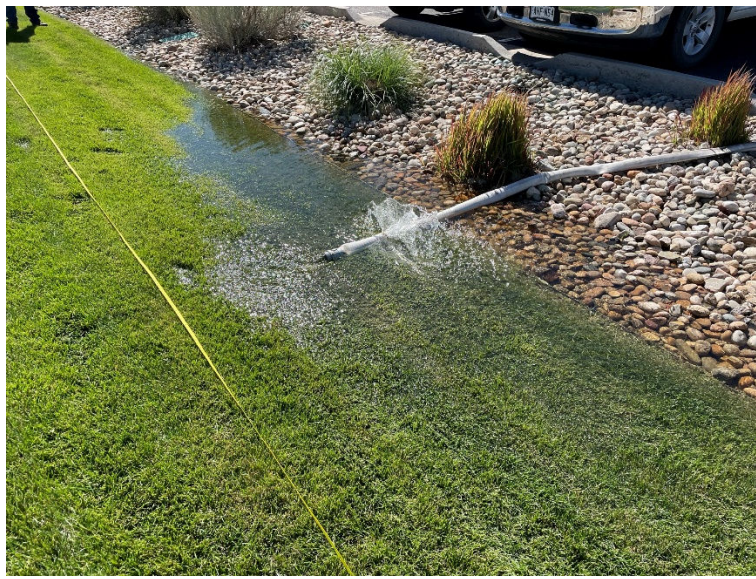
The first SRT was performed using an inflow rate of approximately 80 gpm. The distance from the fire hydrant to the swale was longer than expected which necessitated an inflow point approximately 60 feet upstream of the outlet box. Surface flow was observed in both directions from the inflow point, indicating areas of negative slope along the swale (Figure 27). Surface flow occurred more quickly than anticipated, and sandbags were installed where the slope increased toward the outlet box to impede flow. The water was turned off after 13 minutes and approximately 1,100 gallons. Inflow continued downstream and ultimately overtopped the outlet box (Figure 28).

**Figure 27. Upstream flow (to the left of the fire hose in the photo) observed during the first SRT at Smith & Smith site**

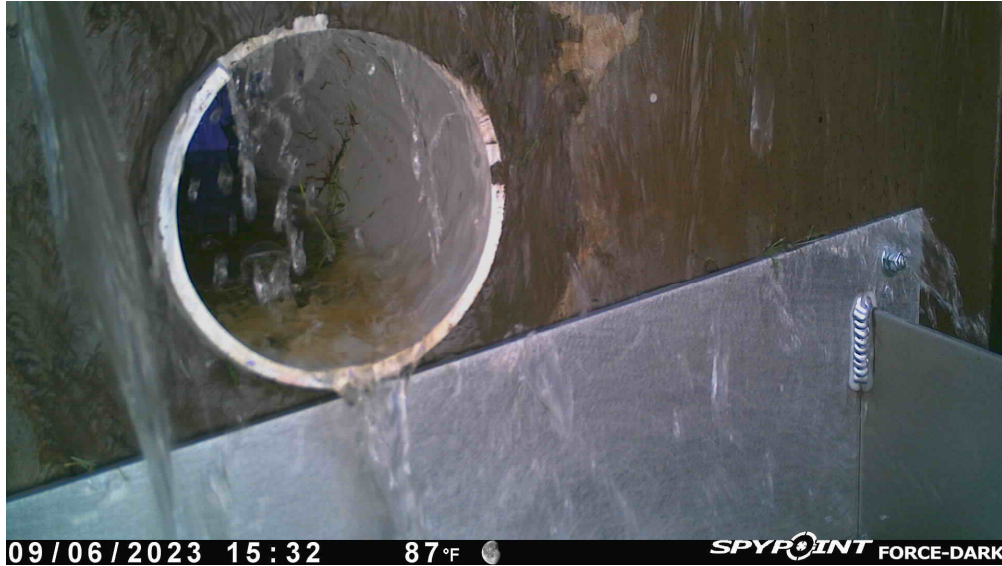
**Figure 28. Flow overtopping the outlet box and outflows from the underdrain observed during the first SRT at Smith & Smith**

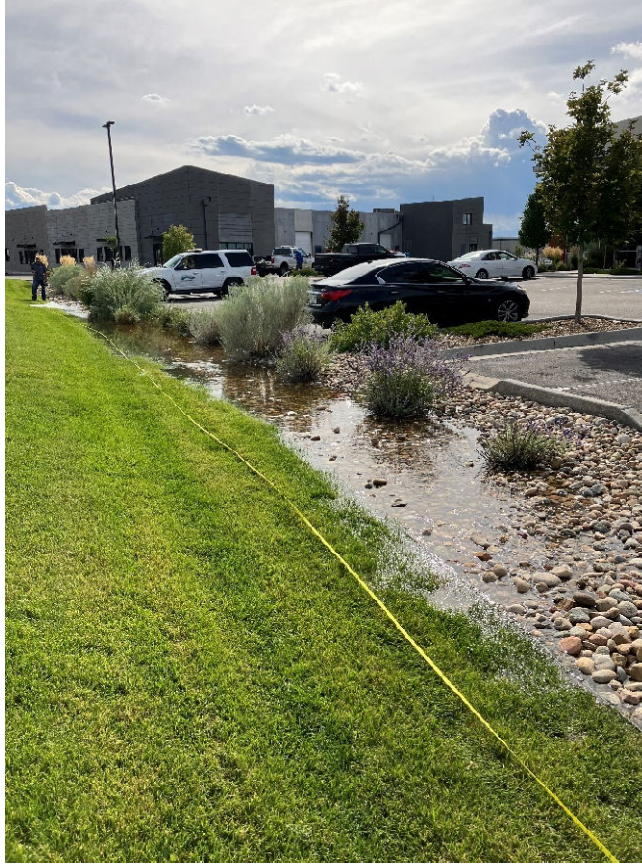
**Figure 29. Flow observed in rocks during SRTs at Smith & Smith site<sup>12</sup>**

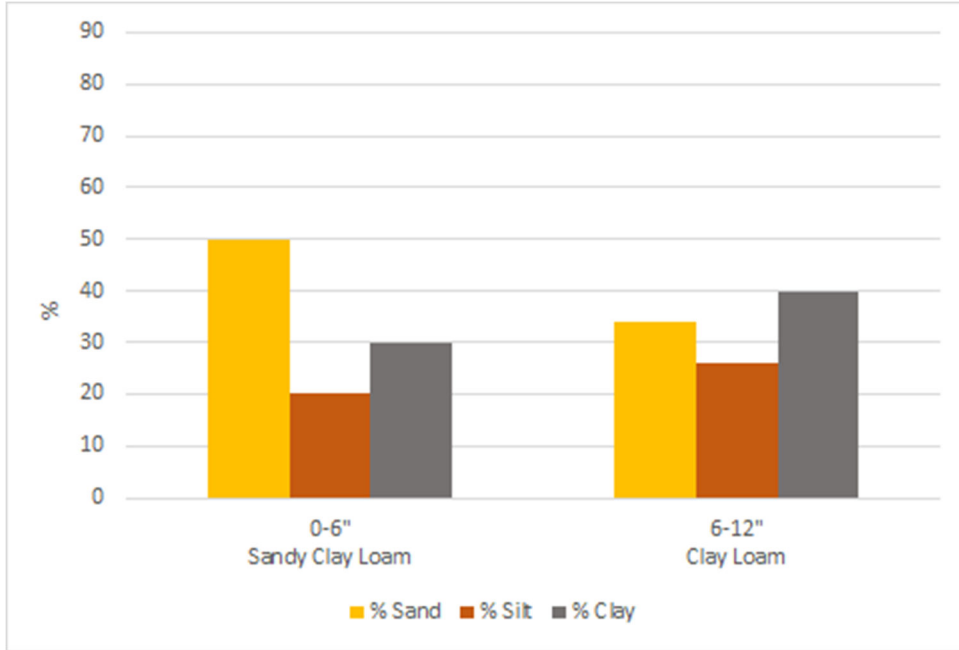
The soil analysis results are not consistent with construction drawings, which reference the MHFD bioretention “growing media” and “filter media.” Specifically, the clay content of the soil samples was considerably higher than specifications (i.e., 30% greater than the specified clay content). The soil analysis was also consistent with field staff observations. Collecting soil samples at this site was very difficult due to the high clay content.

Figure 30. Soil texture analysis of Smith & Smith site

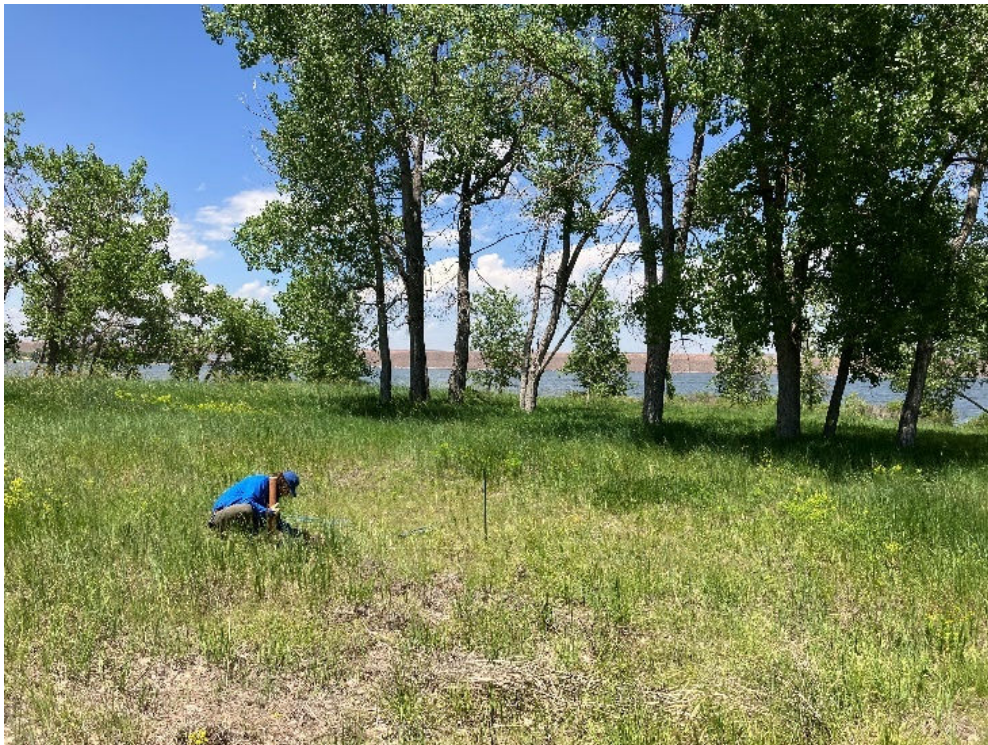
The photographs were used to determine the presence or absence of ponded water in the infiltration basin during precipitation events. In addition, a staff gauge was installed in the center of the infiltration basin to record ponded water depths. Infiltration rates were estimated based on staff gauge readings during precipitation events. Precipitation event data were collected and analyzed as described in previous sections of this report.

**Figure 33. Installation of camera and staff gauge in Lake Loop basin**

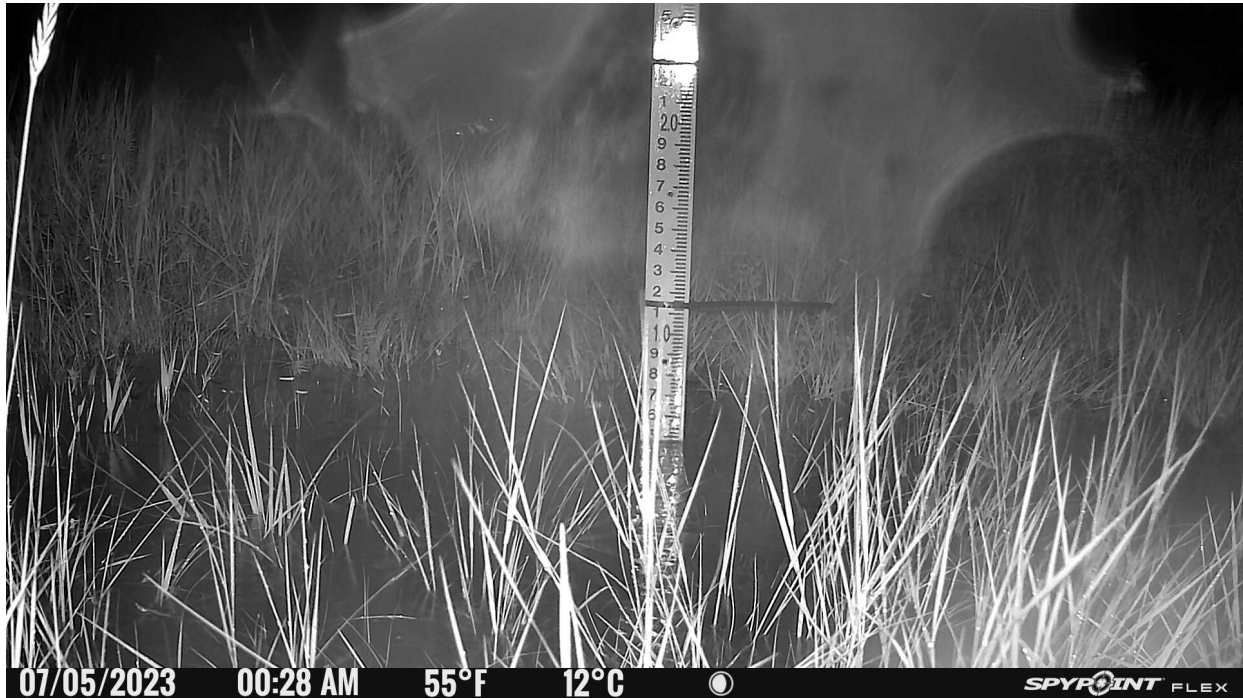
Notably, there were several other events with precipitation depths of 0.4 – 0.6 inches that did not result in any ponded water in the infiltration basin. Those events occurred over longer durations and were less intense than the July 4 – 5 event.

**Figure 34. Ponding observed at Lake Loop basin during the July 4 – 5, 2023, precipitation event**

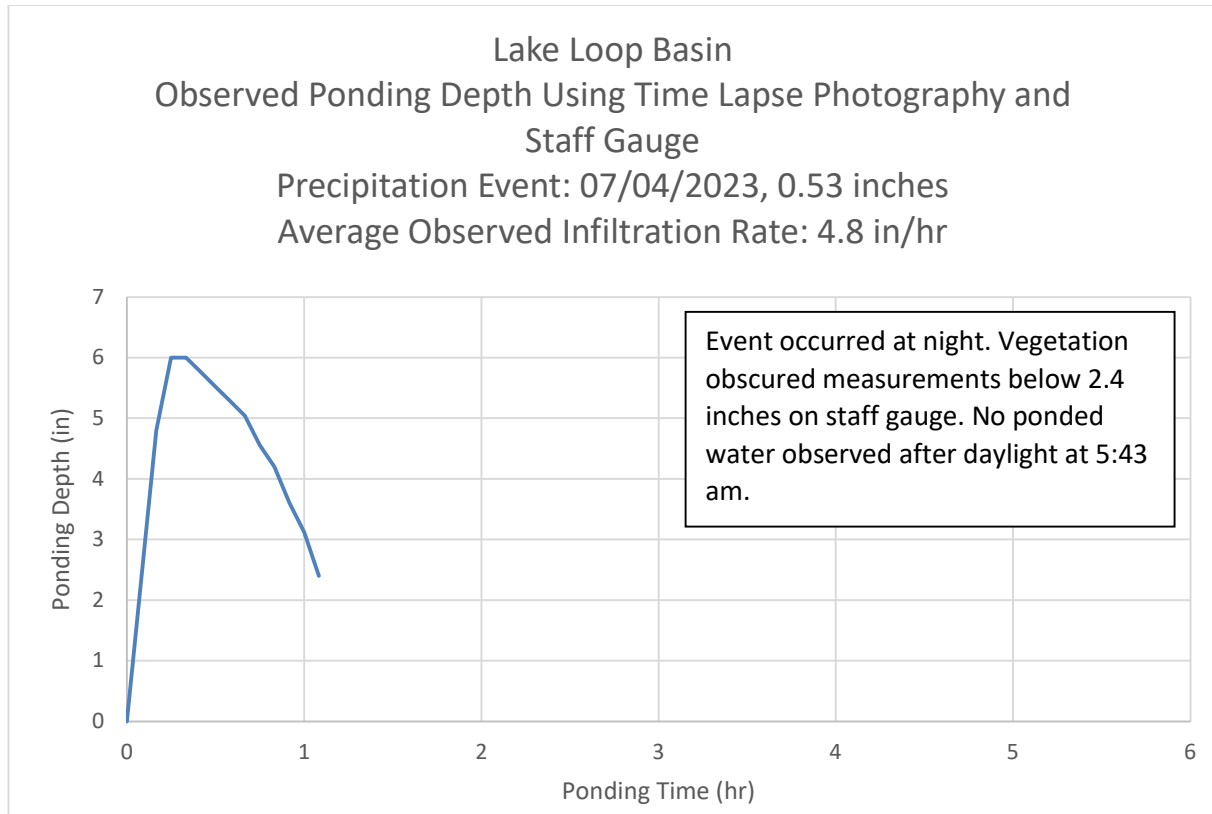
**Figure 35. Ponding event observed at Lake Loop basin on July 4, 2023**

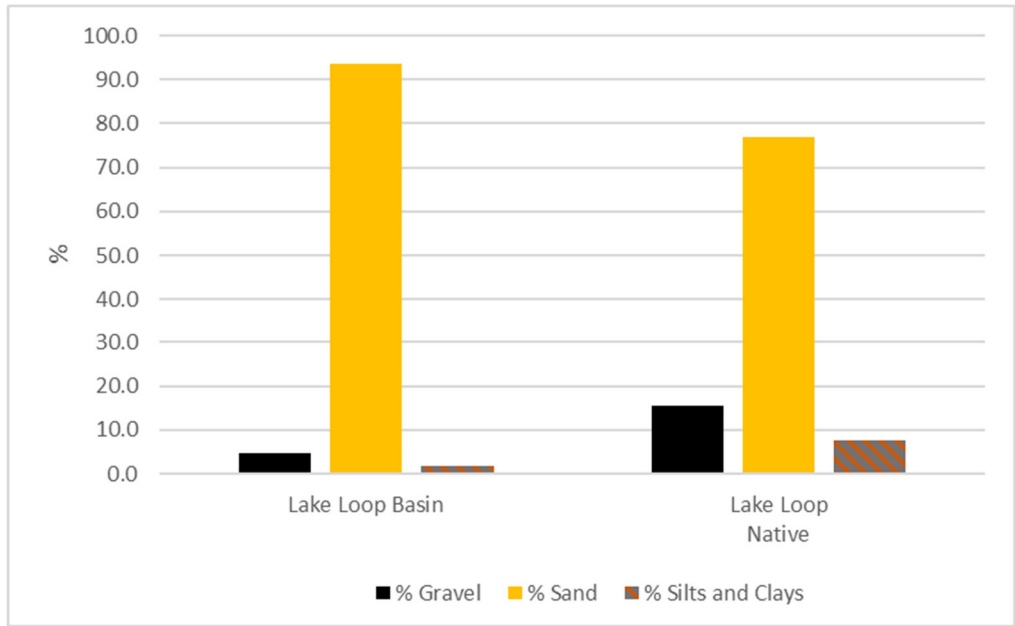
Two 6-inch soil cores were collected at the Lake Loop site, one from the infiltration basin and the other from nearby native soil. Soil particle distribution analysis indicates primarily sandy soil, with less than 10% silts and clays (Figure 36) for both the native soil and the imported infiltration basin media. The infiltration basin soils are consistent with the soil specifications provided by Muller (2013). The native soil exhibits a slightly higher fraction of both gravel (>2.0 mm) and silts and clays (<0.075 mm) compared to the imported soil. Additional details regarding soil analysis, including sample locations and chemical analysis, can be found in Appendix 2.

Figure 36. Soil particle size distribution at Lake Loop basin (per AASHTO soil particle size classification, 1970)
