# Runoff Reduction Field Monitoring in Cherry Creek Basin

Prepared for:  
Mile High Flood District  
Southeast Metro Stormwater Authority  
Cherry Creek Basin Water Quality Authority

Prepared By:  
Chris Olson, PhD, PE  
Stacy Wilson  
2490 West 26<sup>th</sup> Avenue, Suite 100A  
Denver, CO 80211  
(303) 480-1700

June 2024

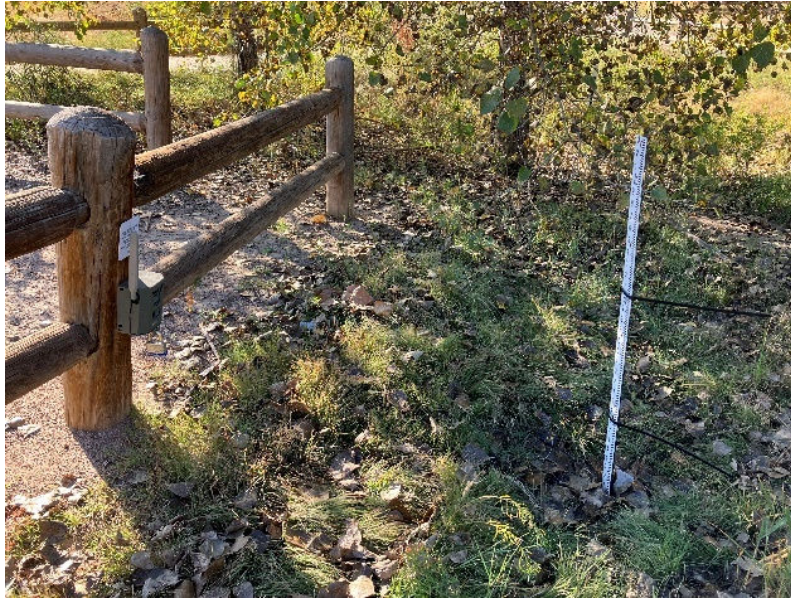
The infiltration basin and swale were monitored using trail cameras programmed to take a photograph every 5 minutes, 24 hours per day. Staff gauges were also installed to document the depth of ponded water during precipitation events (Figure 38 and Figure 39). The cameras and staff gauges were installed on June 28, 2023 and removed November 1, 2023. Due to technical issues with the camera, no photos were taken of the swale from August 11, 2023 through September 26, 2023. Precipitation event data were collected and analyzed as described in previous sections of this report.

**Figure 38. Camera installed adjacent to Mountain Loop swale with staff gauge**

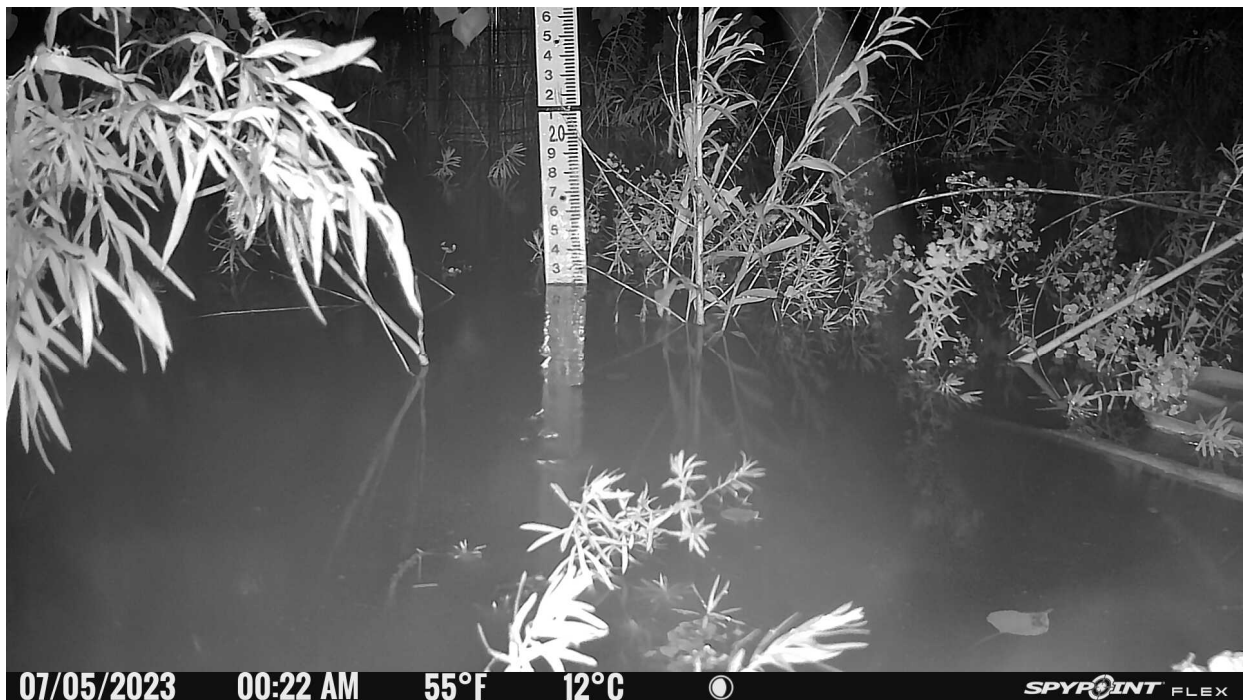
**Figure 41. Ponding observed in the Mountain Loop infiltration basin on July 5, 2023**

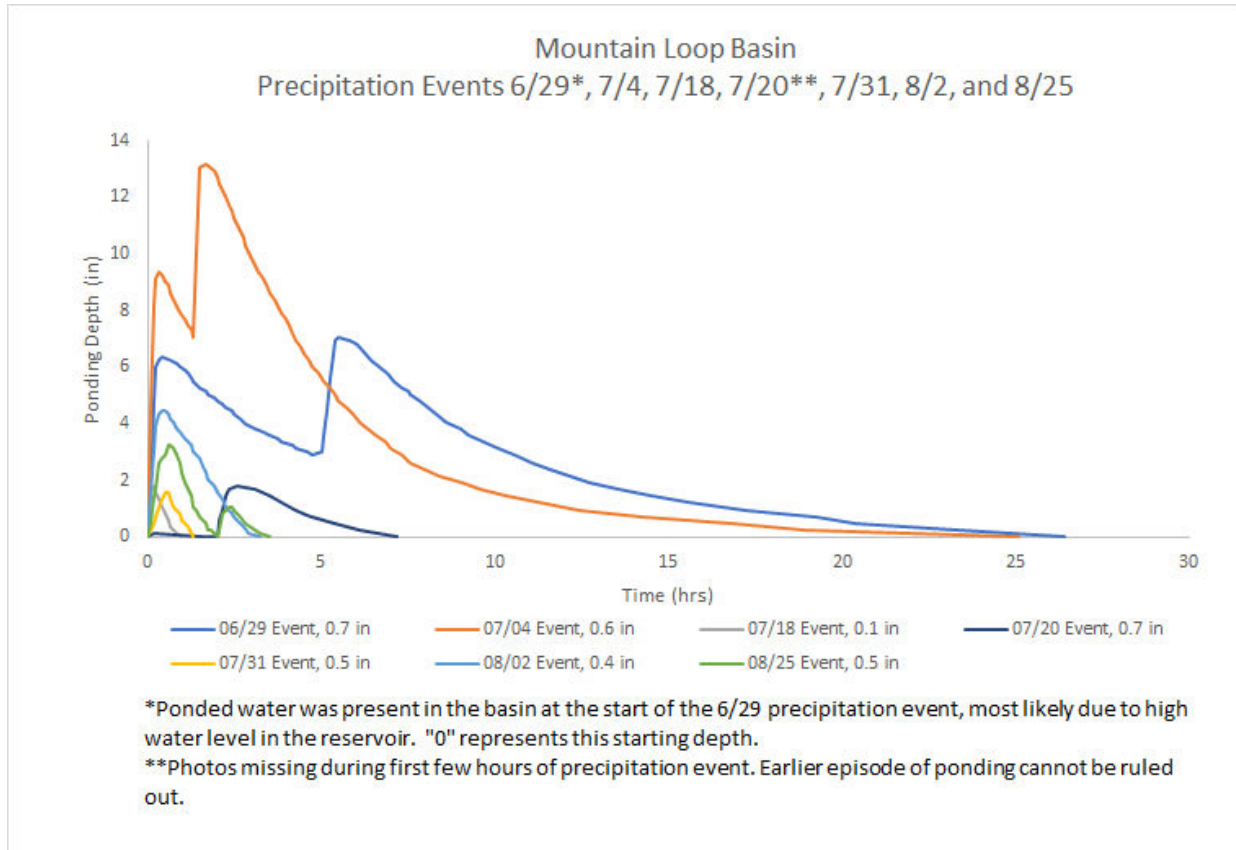
on June 29 was approximately 5,553 feet,<sup>14</sup> which is the same elevation as the bottom of the infiltration basin (Muller, 2013).

**Figure 42. Pounding in Mountain Loop infiltration basin in response to precipitation events**

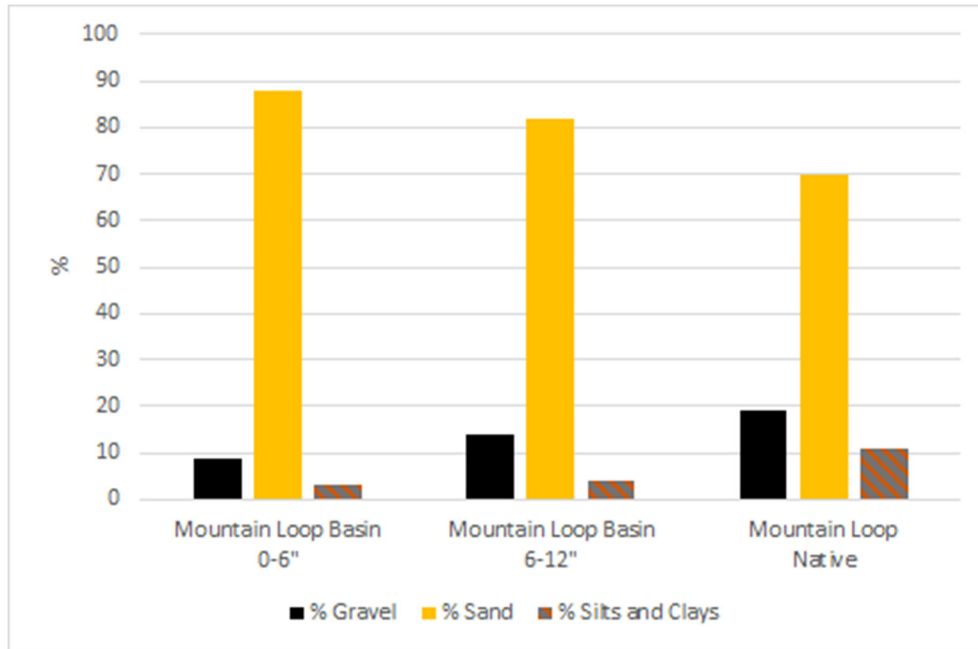
Two 6-inch soil cores were collected at both the Mountain Loop basin and swale at depths 0 – 6” and 6 – 12”. Another soil core was collected from “native” soils nearby. Figure 43 and Figure 44 show the soil particle distributions of those soil cores. The soil samples within the basin and swale are generally consistent with the “sandy loam” media specified in the design drawings (Muller, 2013). The native soil is very similar to the imported media, with slightly higher fractions of gravels, silts, and clays. Additional details regarding soil analysis, including sampling locations and soil chemical analysis, can be found in Appendix 2.

Figure 43. Soil particle size distribution at Mountain Loop infiltration basin (per AASHTO soil particle size classification, 1970)

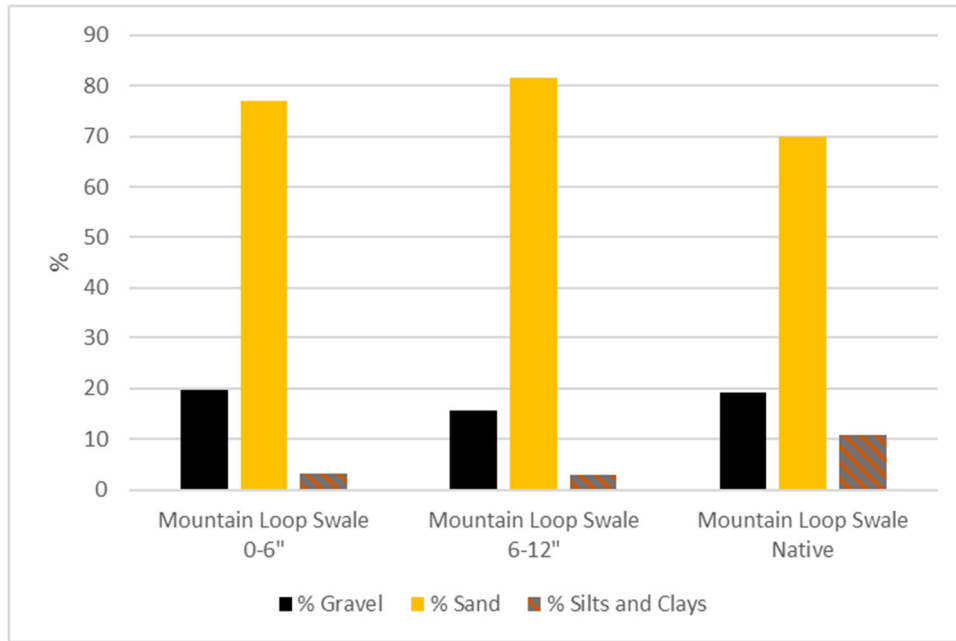
Figure 44. Soil particle size distribution at Mountain Loop swale (per AASHTO soil particle size classification, 1970)

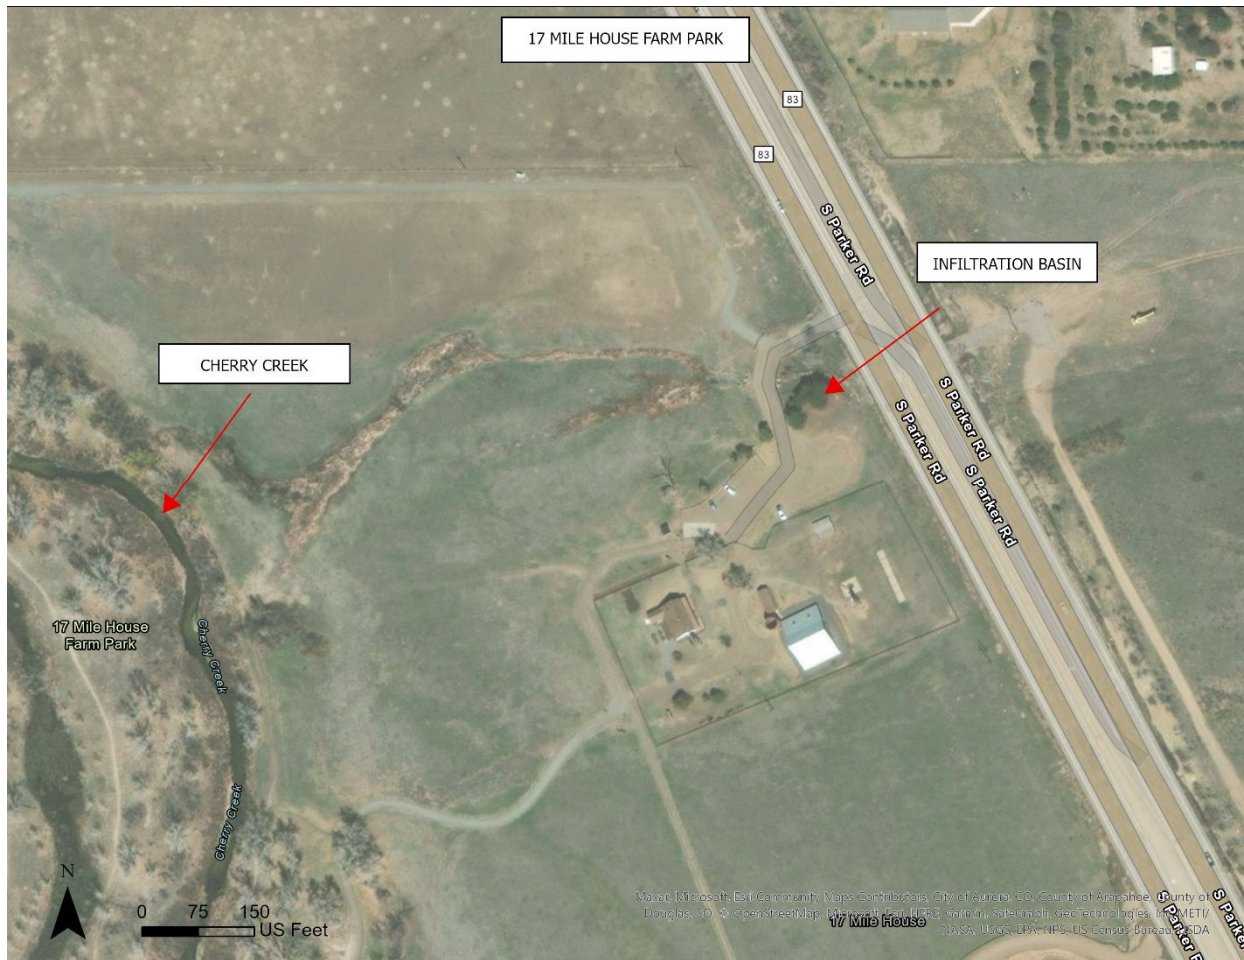
This site was selected for monitoring to evaluate the performance of relatively undisturbed, naturally-occurring depressions that essentially operate as infiltration basins. The proximity of a fire hydrant less than 50 feet away was also a factor in site selection.

**Figure 45. 17 Mile House infiltration basin**

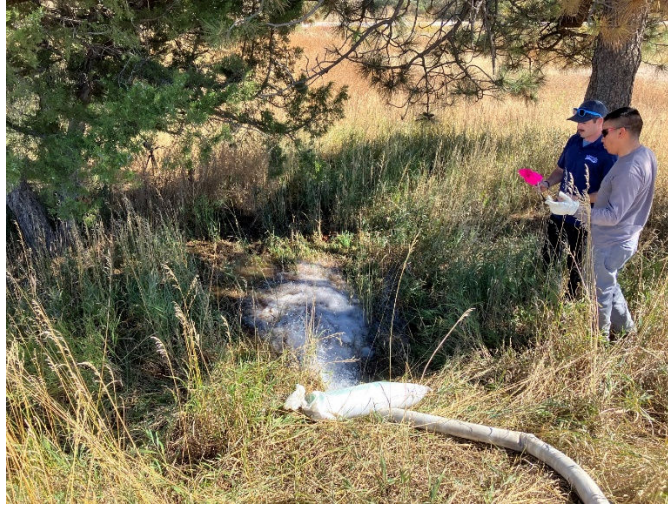
A staff gauge was installed in the basin to measure water levels in the basin during the SRTs. Those measurements were used to estimate infiltration rates and verify other field measurements.

**Figure 46. SRT at 17 Mile House infiltration basin**

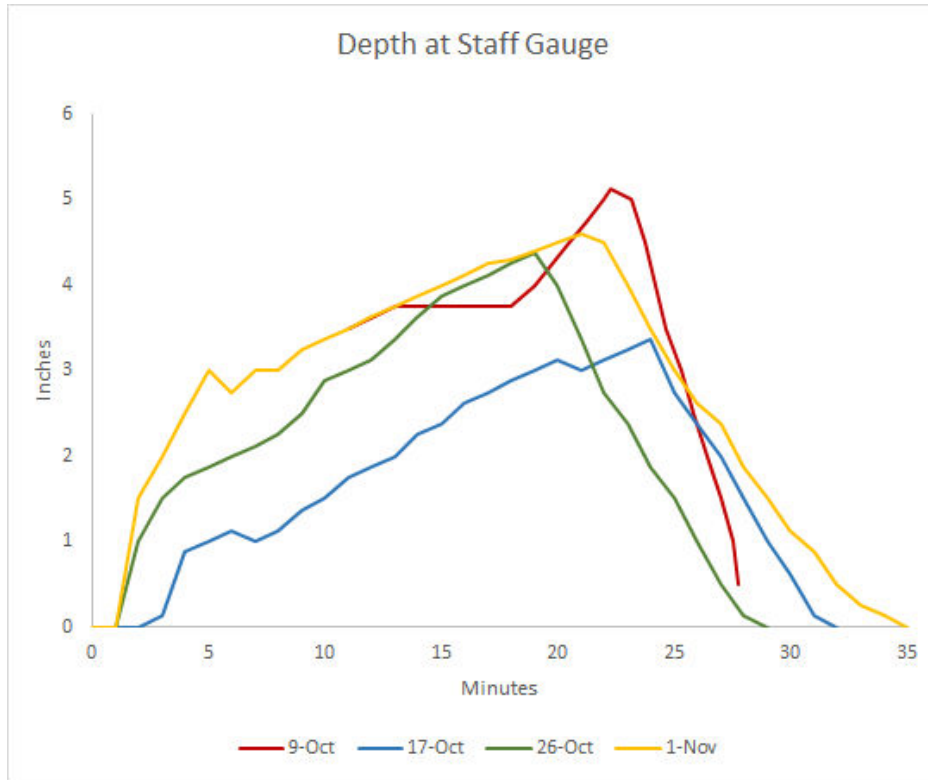
Figure 48. Depth measured at the staff gauge throughout SRTs at 17 Mile House infiltration basin

The maximum wetted surface area delineated during the SRTs ranged from 630 – 910 sf (Figure 47). Staff gauge measurements showed that all water was infiltrated within 10 – 15 minutes after inflows were stopped (Figure 48).

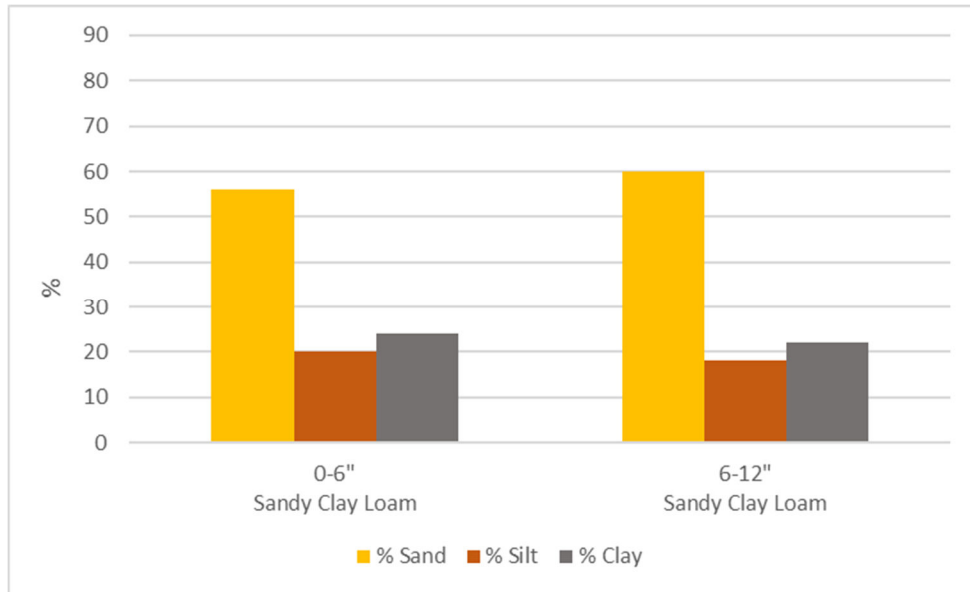
**Figure 49. Soil texture analysis of 17 Mile House infiltration basin**

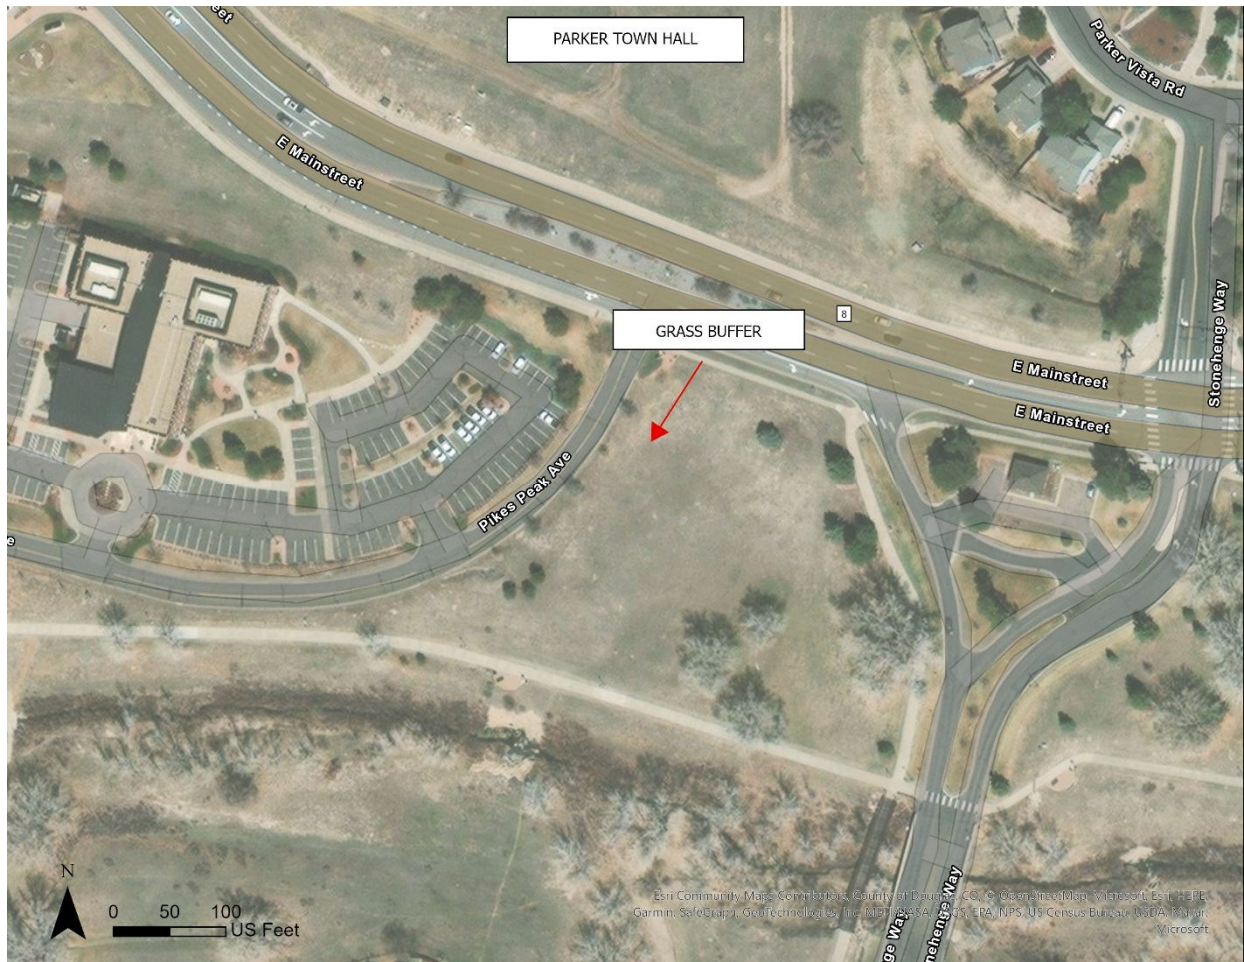
**Figure 52. Parker Town Hall grass buffer site**

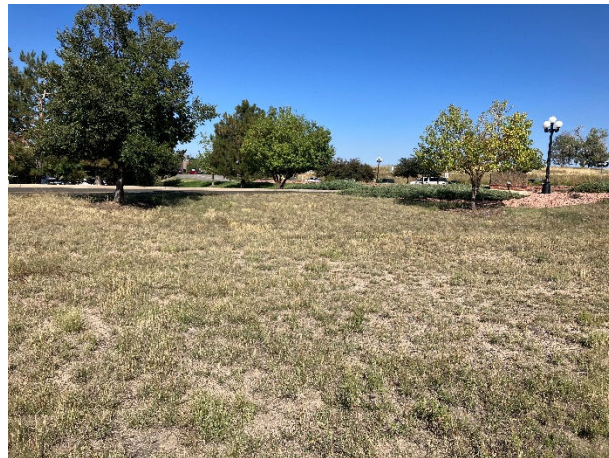
**Figure 53. Parker Town Hall grass buffer**

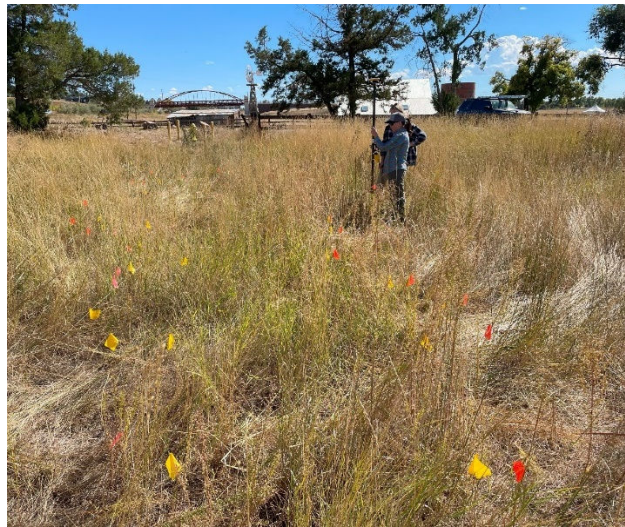
**Figure 54. WVE staff collecting GPS data around the wetted perimeter following SRT**

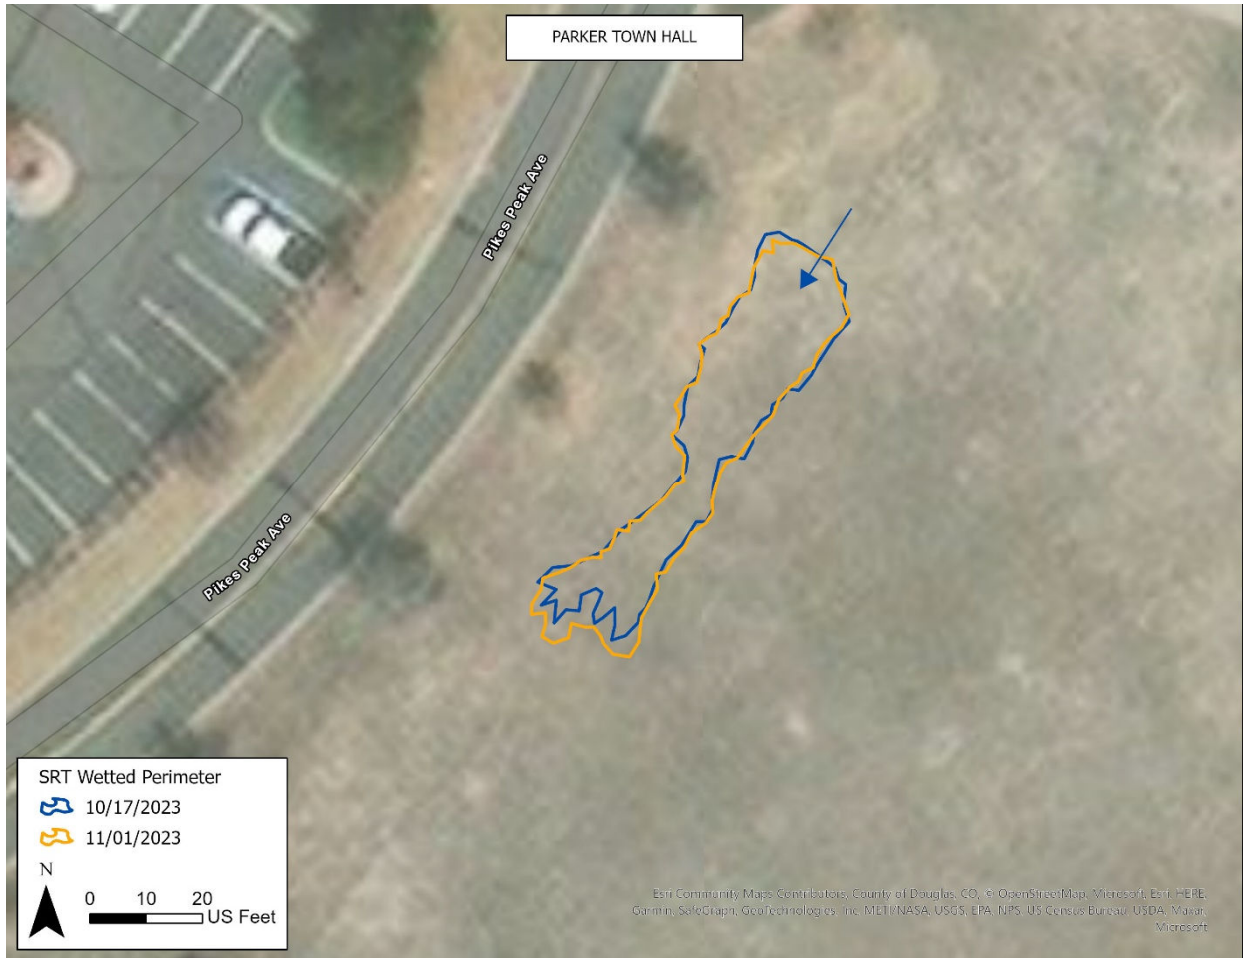
**Figure 56. Wetted perimeter following SRTs at Parker Town Hall buffer**

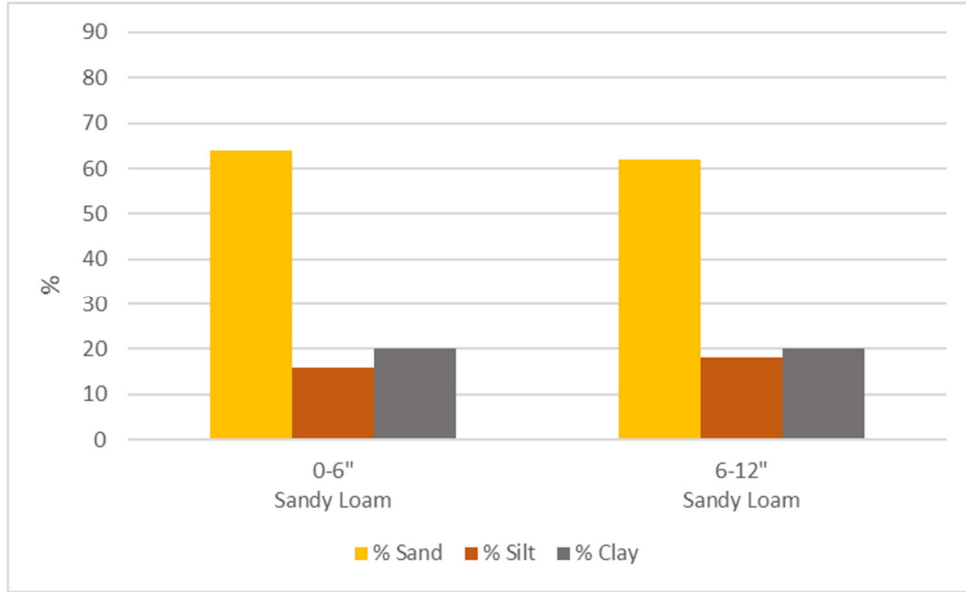
**Figure 57. Soil texture analysis of 17 Mile House buffer**
